# TEST REPORT

**Report number** 15.00798

**Project number applicant** TC15\_112 Vista - Chelsea Bridge London

of an aluminium curtain walling with sliding and tilt window with sizes W x H:  
4604 x 5502 mm constructed from the profile system: CW 50

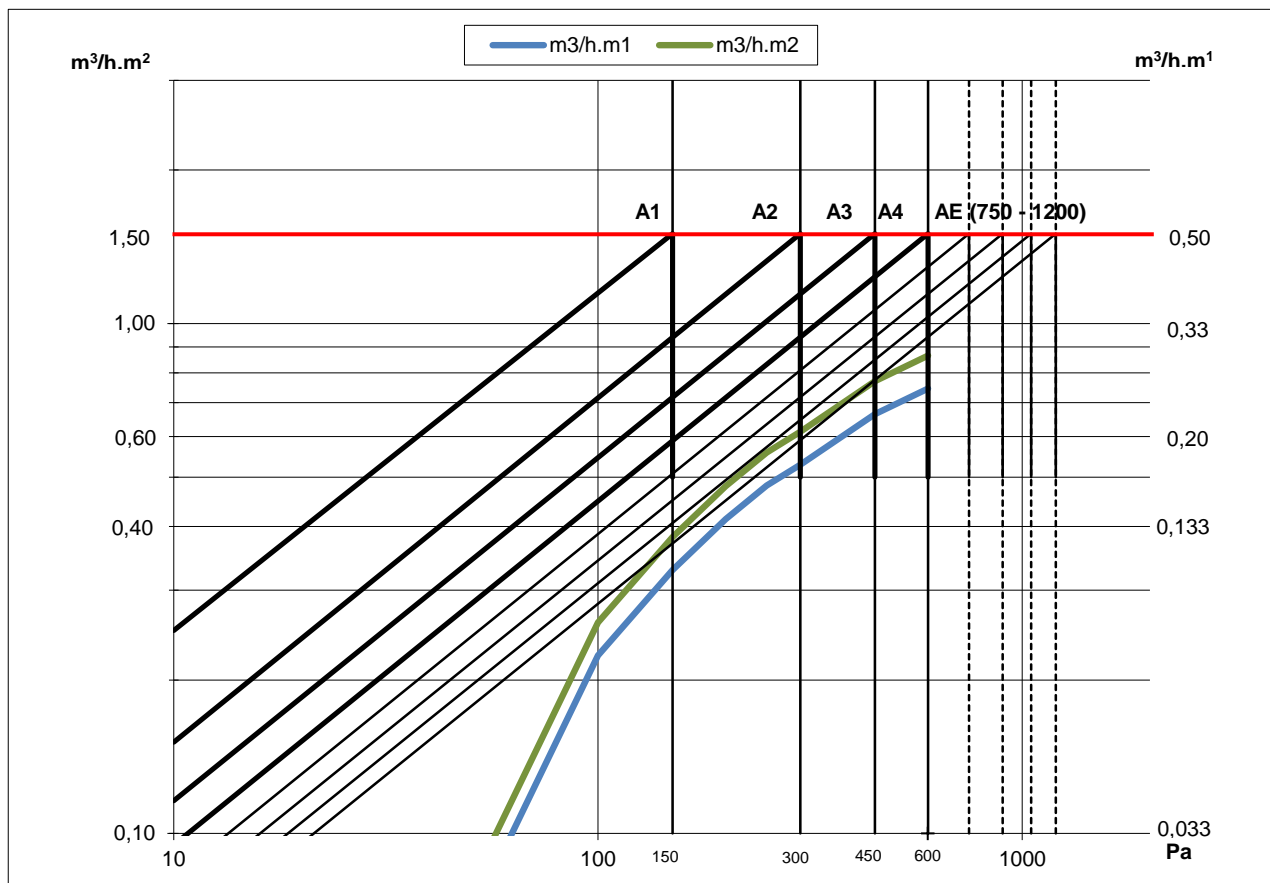
The results of the air permeability measurements under positive key pressure in m<sup>3</sup>/h per m<sup>1</sup> joint length and per m<sup>2</sup> surface are shown in table and graph below.

Result: at positive test pressure

- Air permeability based on length of joint
- Air permeability based overall area

Grade **A4**  
Grade **A4**

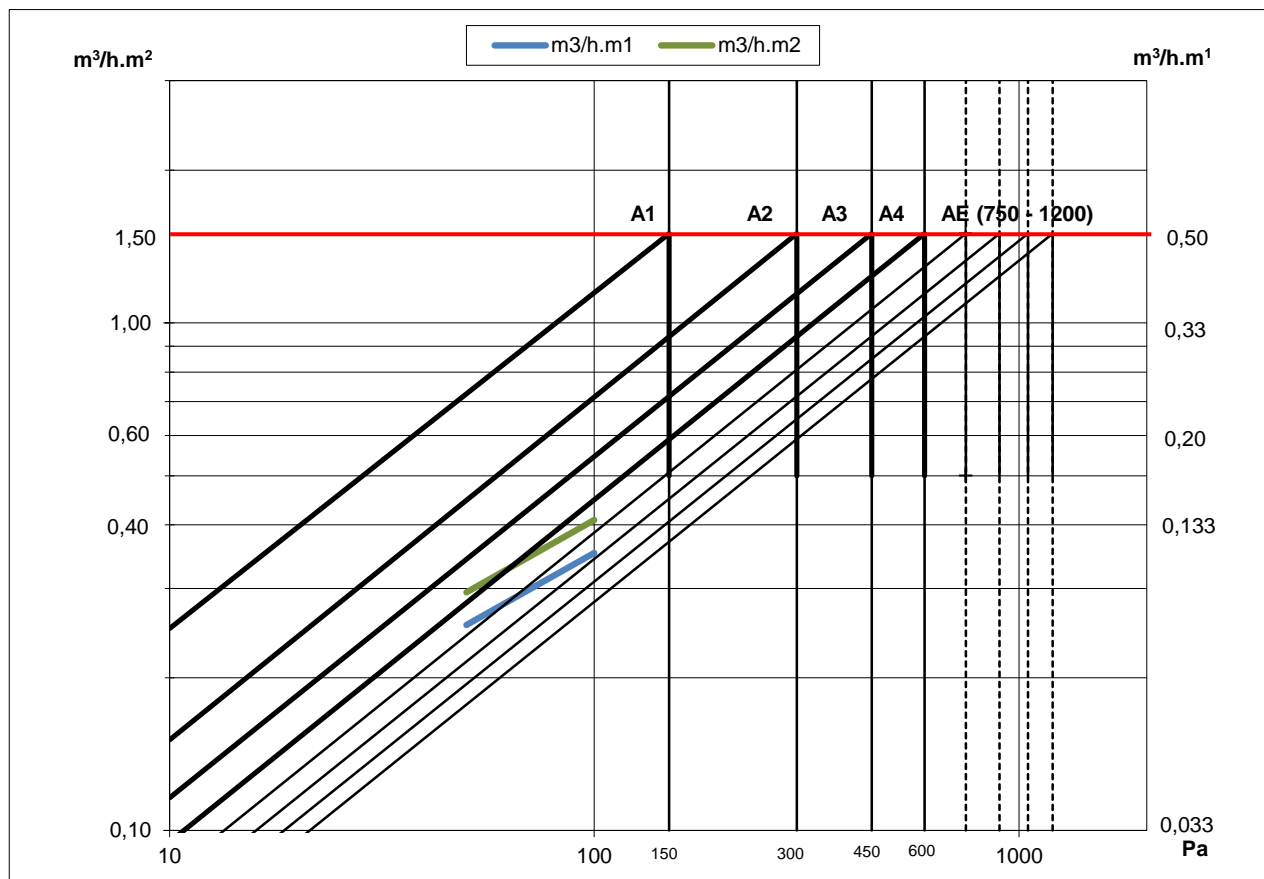
The results of the air permeability measurements under negative key pressure in m<sup>3</sup>/h per m<sup>1</sup> joint length and per m<sup>2</sup> surface are shown in table and graph below.

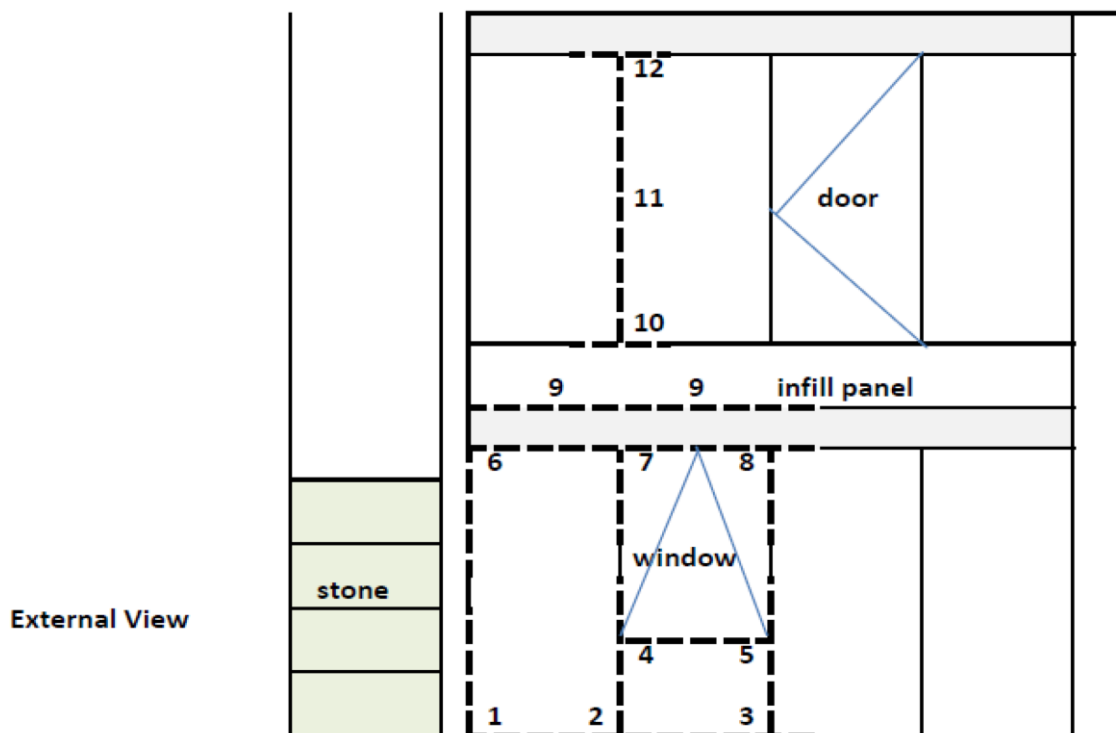
Positions Hose spray test

Position <sup>1)</sup>	t (min)	Water leakage
1	4	no
2	4	no
3	4	no
4	4	no
5	4	no
6	4	no
7	4	no
8	4	no
9	4	no
10	4	no
11	4	no
12	4	no

<sup>1)</sup> Positions are indicated on page 13
